**Developing a Community Centric Early Warning Protocol for Landslide Early Warning System (EWS) to build resilience of communities exposed to hydro-climatic hazards in Bagmati Province of Nepal**

## **BASELINE REPORT**

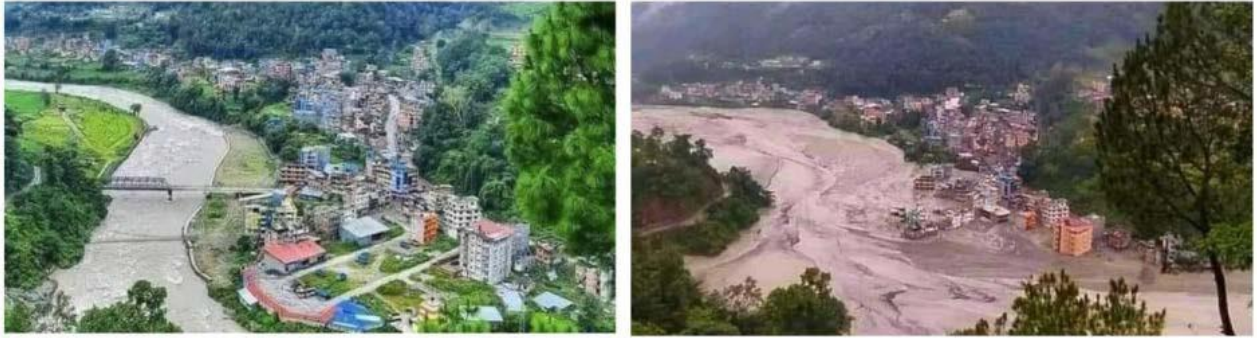
Figure 3-1. (left) Melamchi town before the debris flow event and (right) after the debris flow event (Masi et al., 2021).

The Melamchi flood disaster is one of the eye-opening events in the mid-mountain region of Nepal. Over the past quite a few studies were carried out (Masi et al., 2021; Schindler et al., 2012; Zhuang et al., 2022). These studies stated that the flash flood was caused by continuous rainstorms of several days that caused landslide dam in the upstream of the Melamchi River and at some point, the dam was breached. The breach was sudden caused huge debris flows.

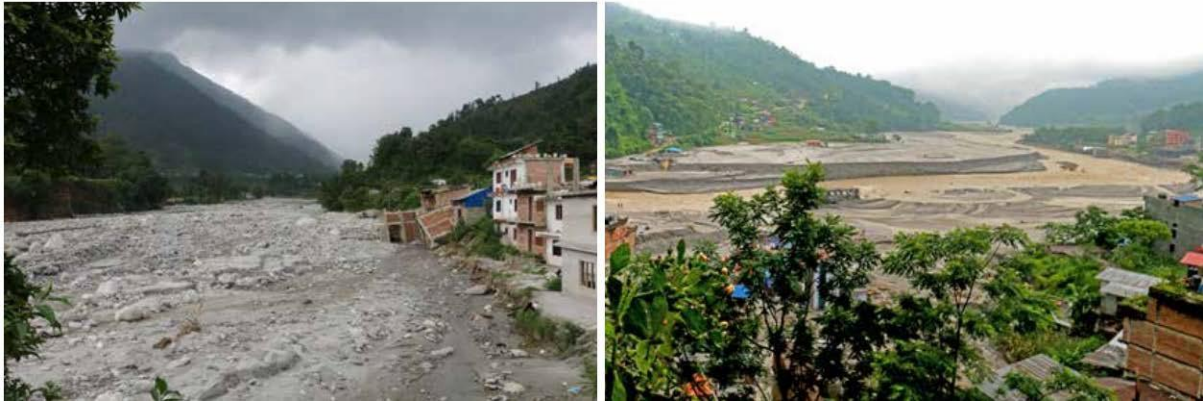
**Figure 3-4. Sediment deposition in the a. upstream part about 1 km upstream from Chanaute Bazaar and b. downstream part (Melamchi Bazaar) of the watershed (Source: ICIMOD 2021).**

the damming material and breached out, causing the catastrophic flood that resulted in major damage in the downstream areas (**Figure 3-4**). According to Masi et al. (2021) the landslide mass was about 670,000 m<sup>3</sup> in volume.

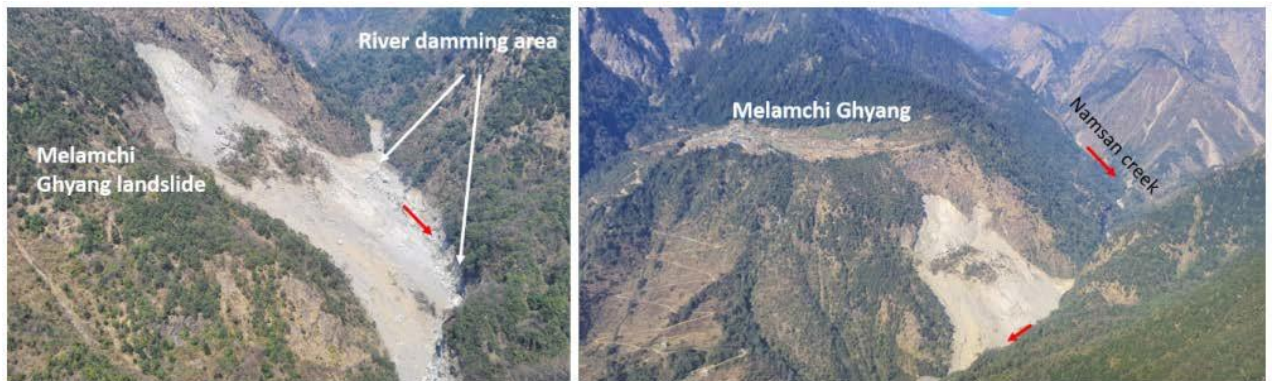
**Figure 3-5. View of Melamchi Ghyang Area and landslides that caused landslide dam (Sources WB, 2021).**

Following the debris flow disasters, World Bank carried out assessment of Melamchi Watershed with the goal to support National Disaster Risk Reduction Authority (NDRRMA); to bring the concerned stakeholder in a place and assess the degree of disaster and prepare recovery plan.

Firstly, they carried out mapping of the area using the Drones and secondly assess the amount of the debris deposited in the downstream area followed inundation modeling of the area. They implemented events-based Rain-on-Grid Model in HEC-RAS to derive the hydrograph, which was used to model the inundation areas (Schindler et al., 2012)

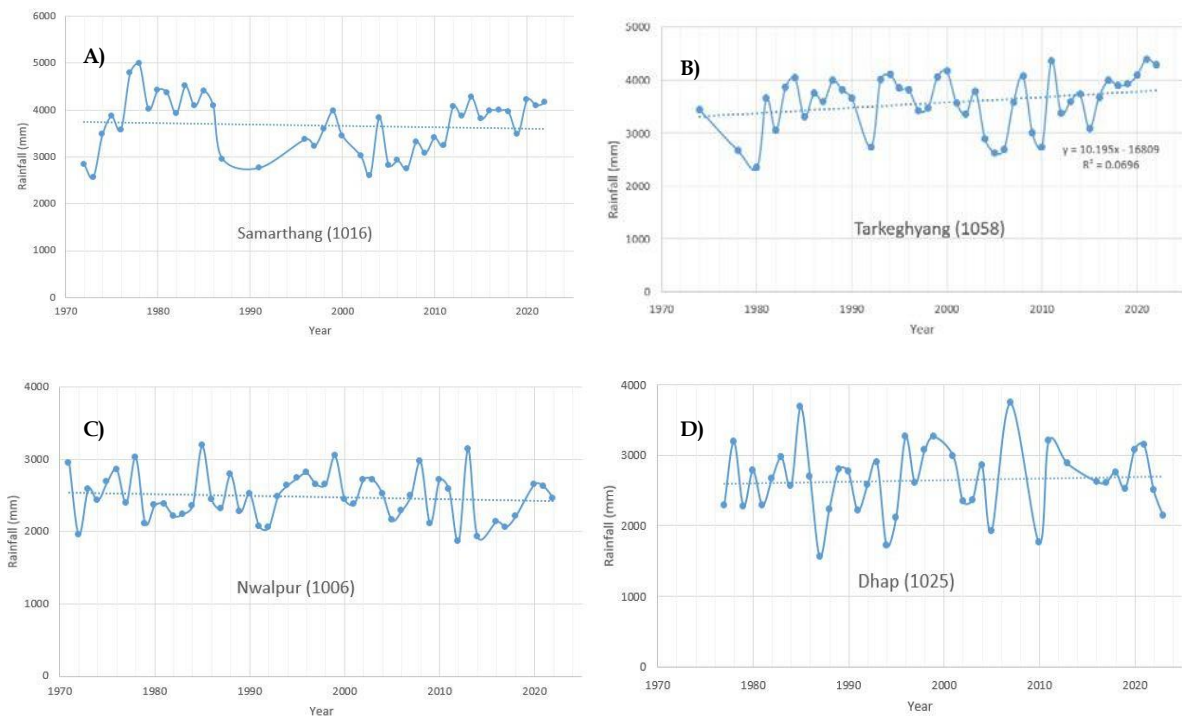
**Figure 5-2. Historical rainfall trend; A) Sarmathang, B) Tarkeghyang, C) Nawalpur and D) Dhap.**

The maximum rainfall as discussed earlier was recorded in Sarmathang and lowest was in Nawalpur. There was no distinct and significant trend of rainfall in the region rather it was monotonous (Figure 5-2).

Among the four stations, the historical annual total rainfall in Sarmathang and Nawalpur depicted to be decreasing with very low significance while Tarkeghyang indicated increasing trend. Over 50 Years data of Dhap does not show any trend.
